COLORADO DEPARTMENT OF TRANSPORTATION  
OFF-SYSTEM BRIDGE INSPECTION PROGRAM  
ESSENTIAL BRIDGE REPAIRS DOCUMENTATION FORM

Structure Number: 083000N01.80016 (MTZ-016)

Feature Intersected: Alkali Canyon

**Colorado Department of Transportation**  
**Structure Inspection and Inventory Report (English Units)**

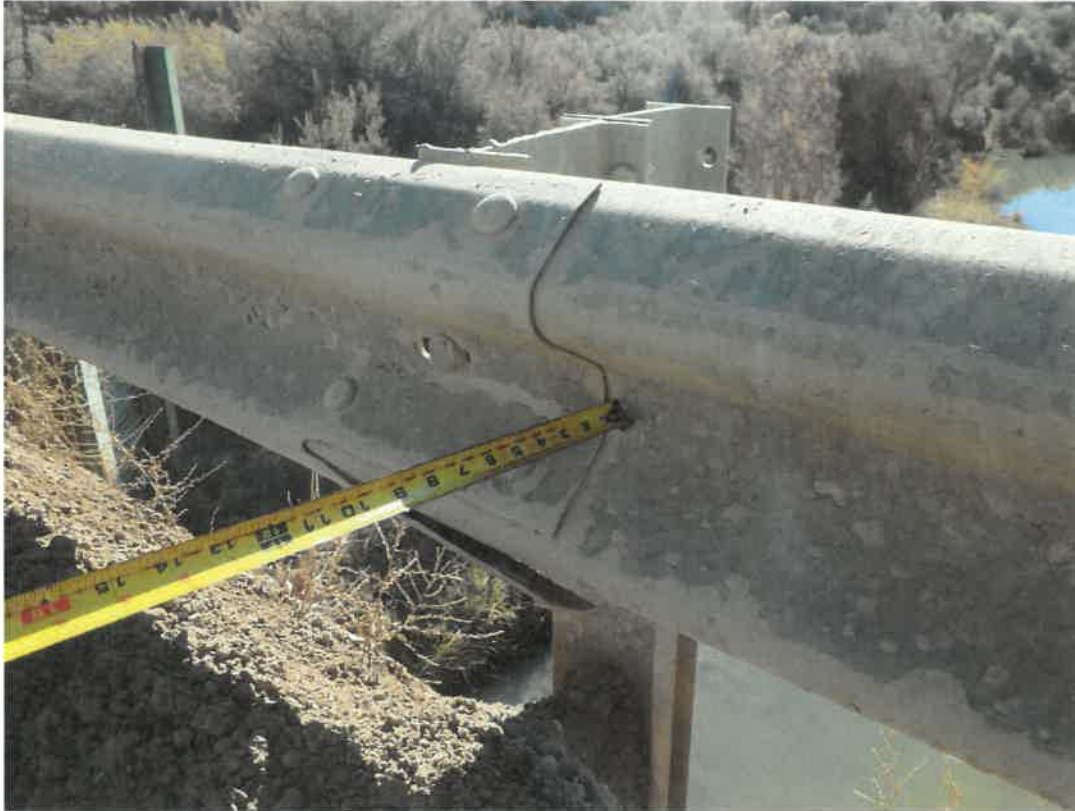
W-Beam Lapped in Wrong Direction and Perforated End - Various Occurrences

Loosen bridge rail on both sides of bridge and lap in proper direction.

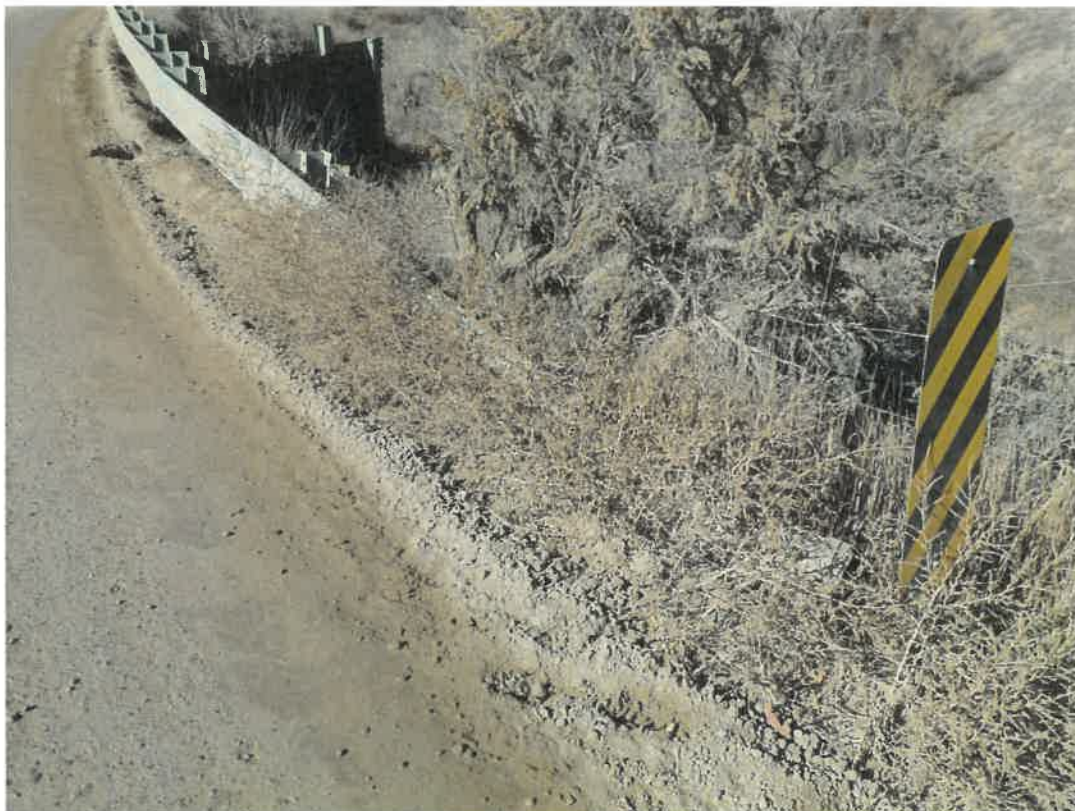
Vegetation Growing in Front of Low Northeast Approach Rail

Cut brush on approach roadway at northeast corner on inside of curve to improve sight distance.

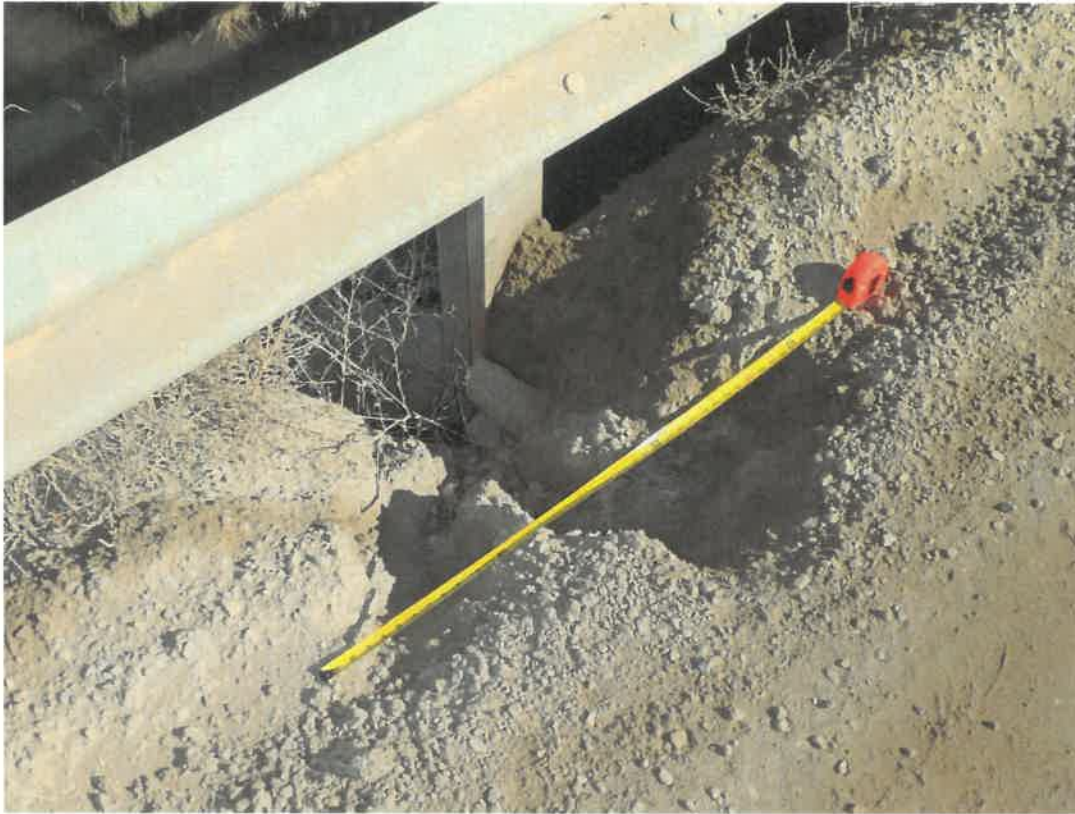
Erosion at Northwest Corner of Deck beginning to Encroach on Roadway –  
Similar at Northeast

Raise tops of wingwalls 2 feet at all corners to retain fill and mitigate erosion encroaching into roadway.

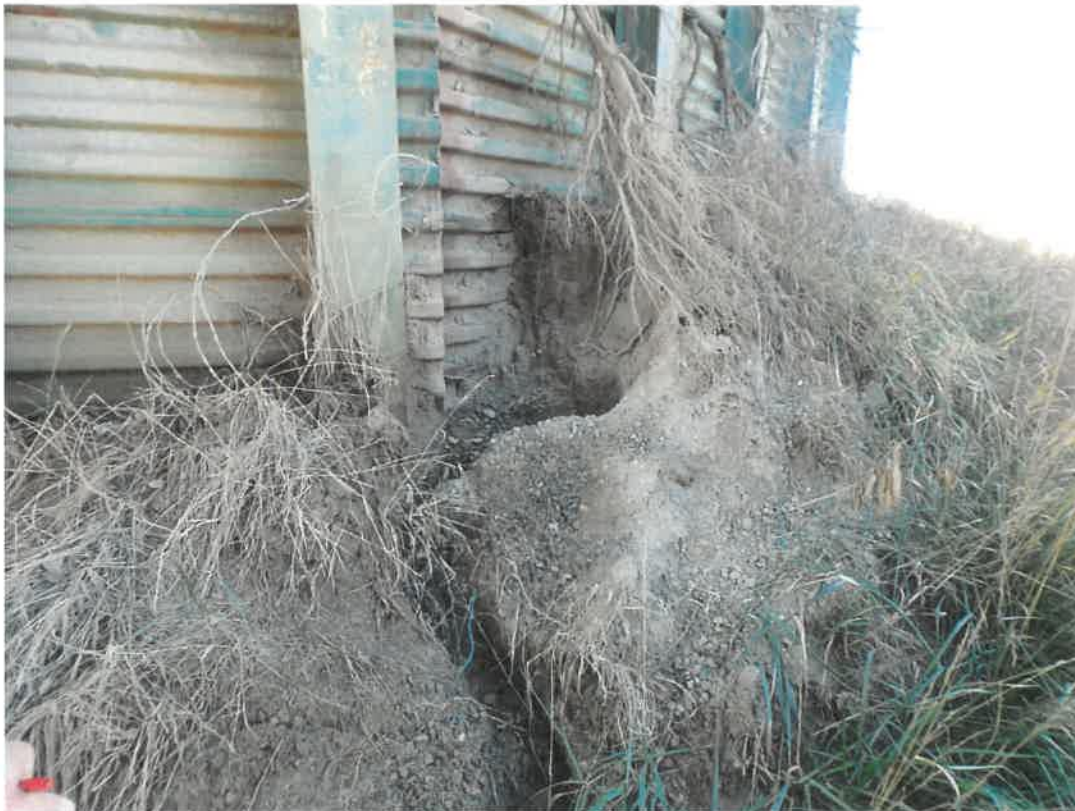
Erosion Trough at North End of West Abutment - Correlated to Erosion at Corner of Deck  
Above

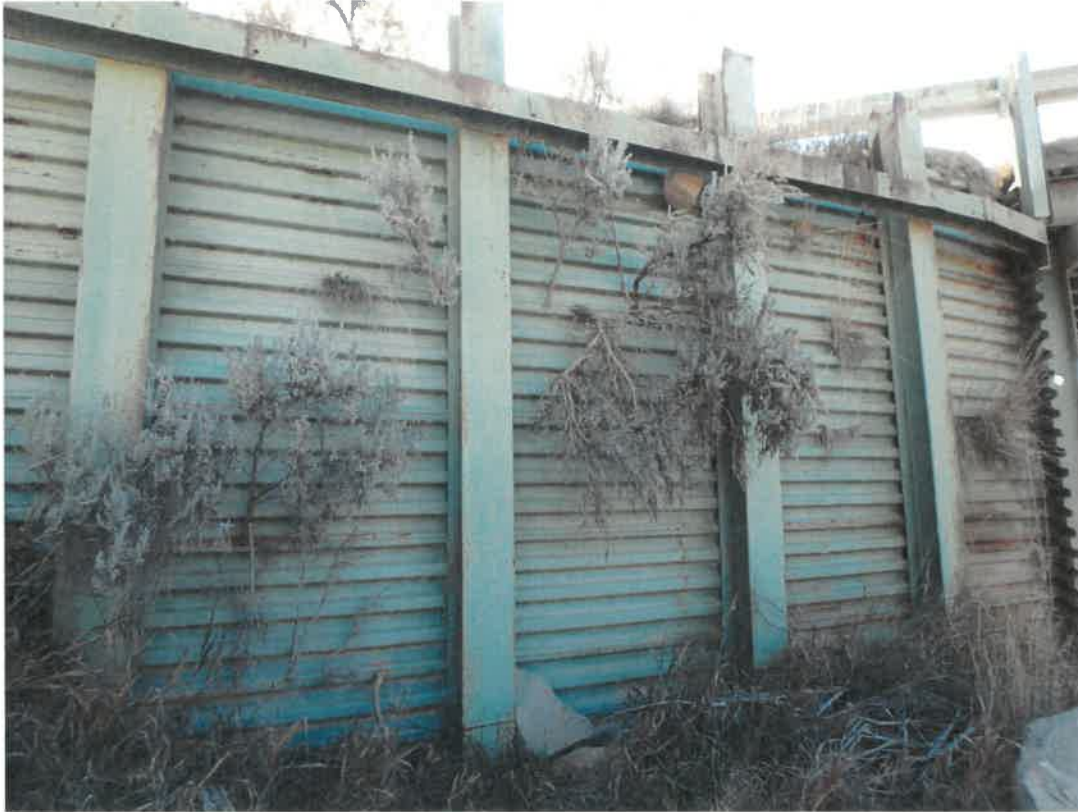
Vegetation Growing out of Northeast Wingwall - Similar at All Others

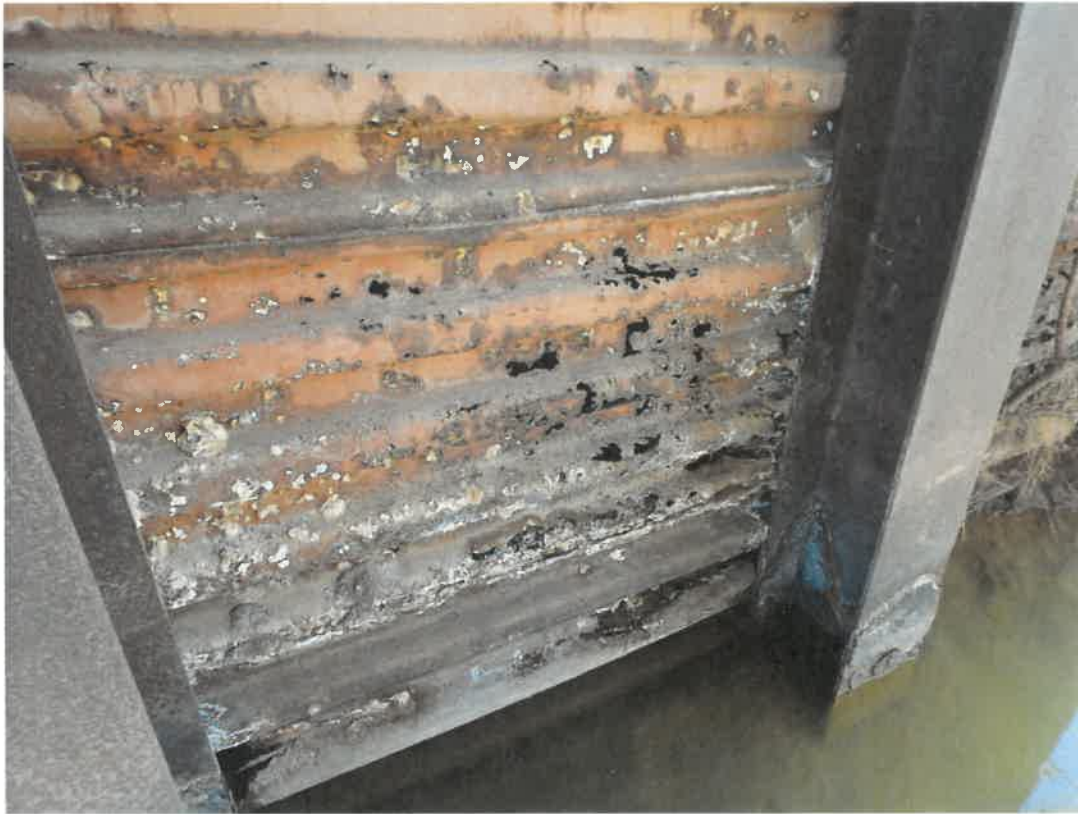
R4 rusting near ground line and holes at east abutment (A2) between Piles C and F.

R4 Rust with Holes in East Abutment Backwall - Between Piles 2D and 2E Shown

Replace or repair heavily corroded corrugated metal  
cribbing at the east abutment and northwest  
and northeast wingwalls.

Replace backwall at the east abutment (A2) and north and east wingwalls. Alternatively, encase piles and backwall at A2 in concrete for 2 feet below existing groundline and 4 feet above existing waterline.

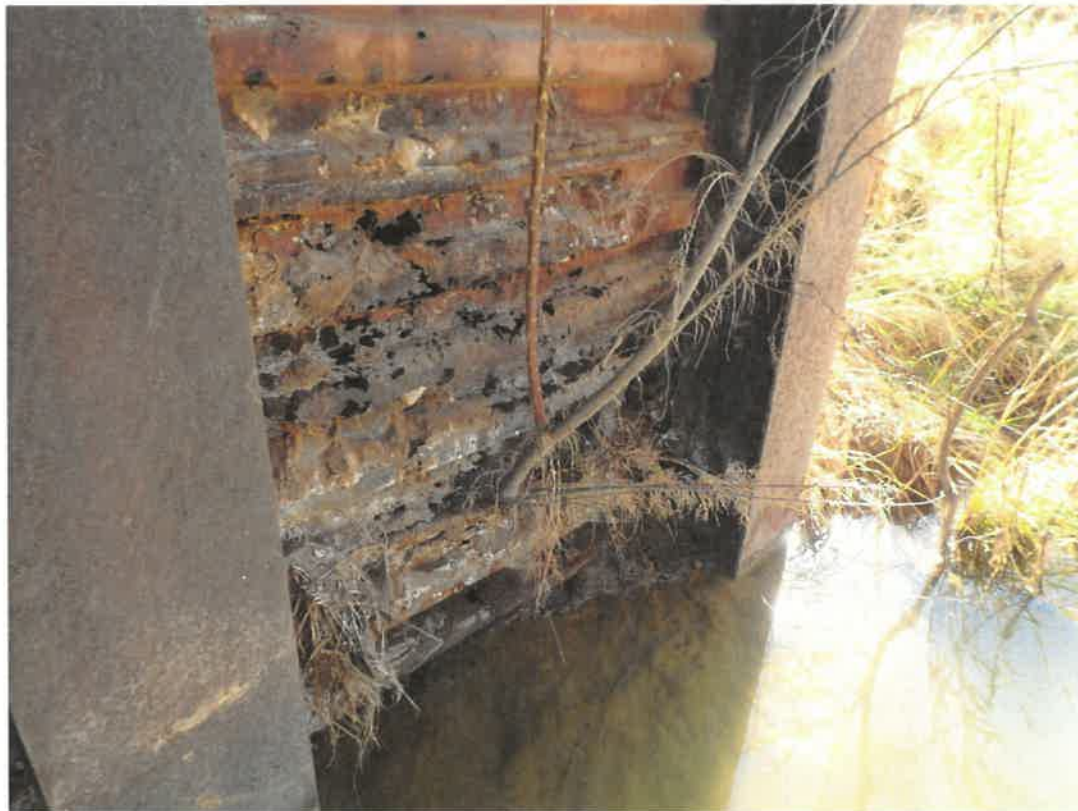
R4 Rust with Holes, Voids and Vegetation Growing in East Abutment Backwall – Between Piles 2E and 2F Shown

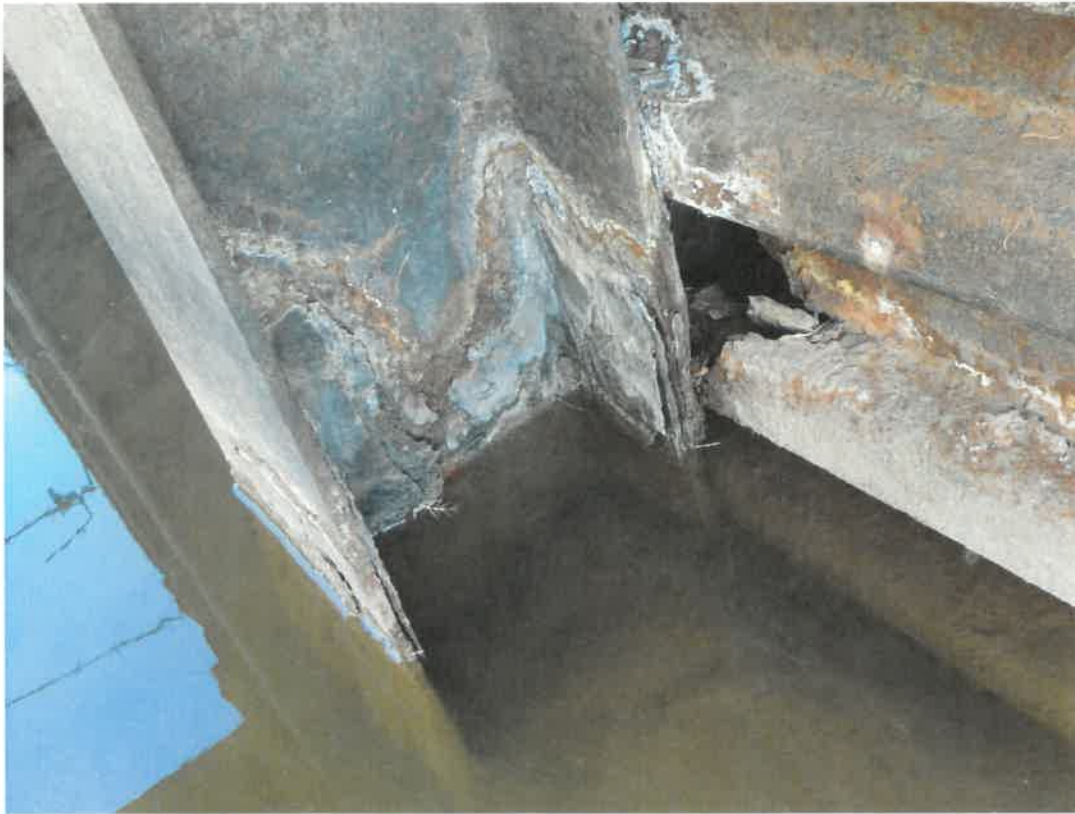
Heavy R3 rusting with up to 29% section loss at waterline of Piles 2D-2F (7/16 inch normal flange and now 5/16 inch).

Flaking Layers of R3 Rust on Pile 2D - Section Loss Evident

Consider encasing the piles at the east abutment in concrete  
to mitigate further deterioration.

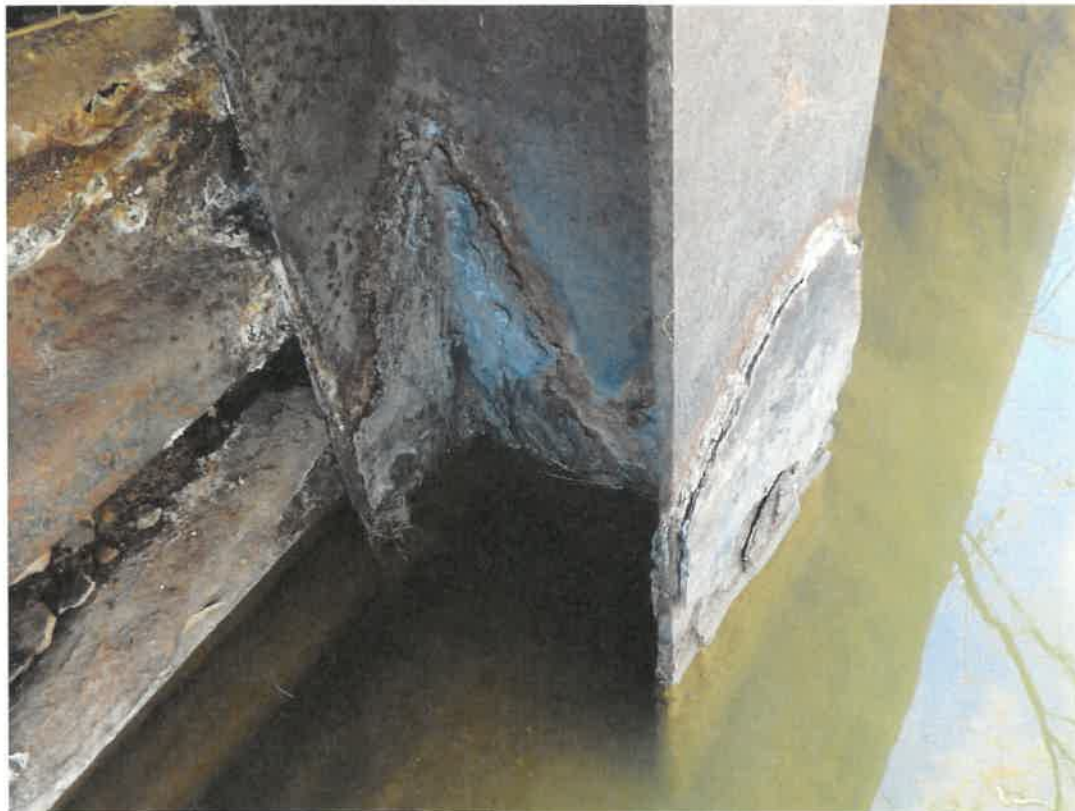
Flaking Layers of R3 Rust on Pile 2E - Section Loss Evident

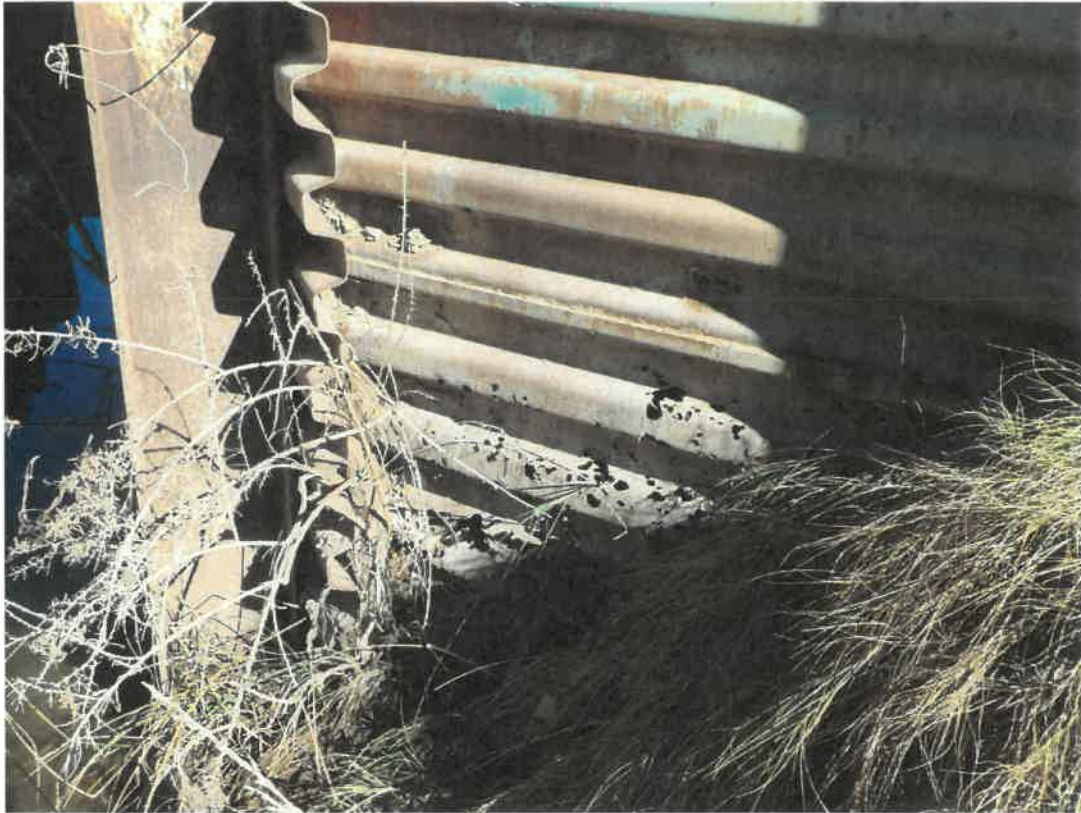
R4 Rust with Holes, Voids and Vegetation Growing in Southeast Wingwall Cribbing
