**Aquatic Resources Delineation Report  
Alkali Creek Bridge Replacement Project  
(CDOT 22521, BRO C320-004)  
Montezuma County, CO**

**Montezuma County  
Road & Bridge Department  
1680 North Dolores Road  
Cortez, Colorado 81321**

**July 2020**

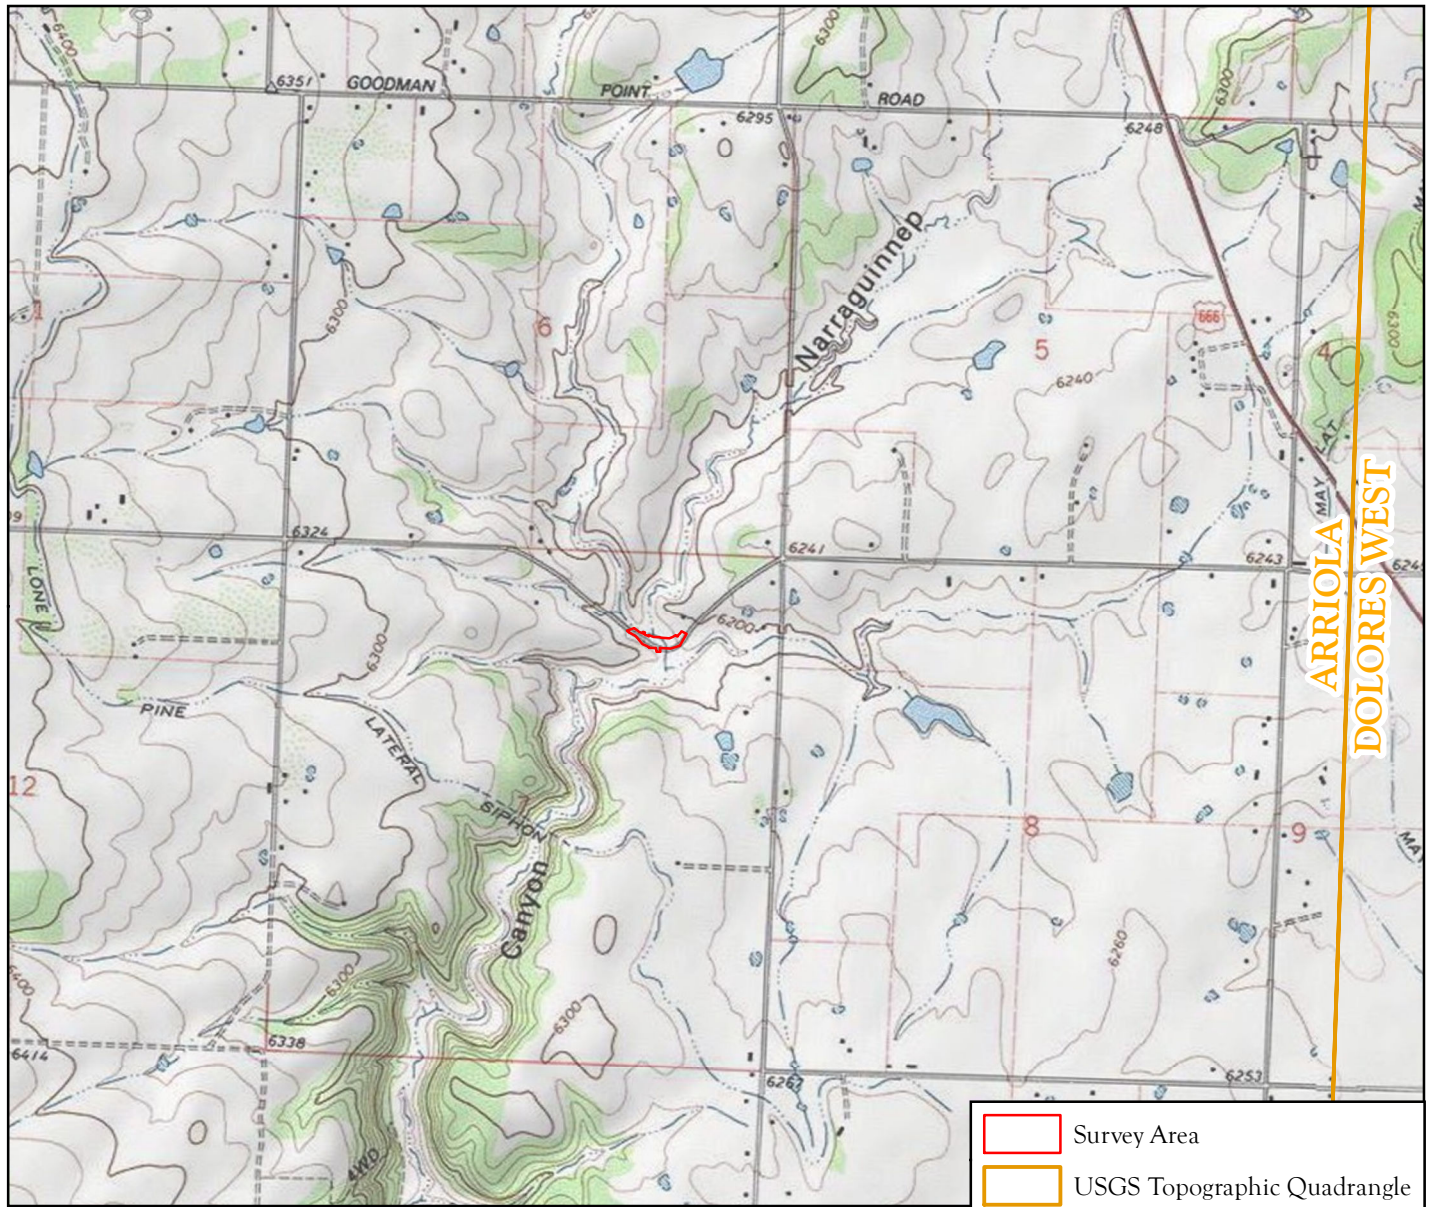
**FIGURE  
B2**

**Elevation Range of Site:** Approximately 6,170 to 6,200 feet above mean sea level (msl) ([Figure B2](#)).

**Geographic Setting:** The survey area is located northwest of Cortez, CO. Alkali Creek runs perpendicular to Rd N in the center of the survey area. The creek flows south through the survey area boundary before flowing generally south to McElmo Creek. Alkali Creek is mapped as an intermittent waterway on the USGS Arriola, Colo. 7.5-minute Topographic Quadrangle 1:24,000, Colorado map.

**TOPOGRAPHIC SITE LOCATION MAP**

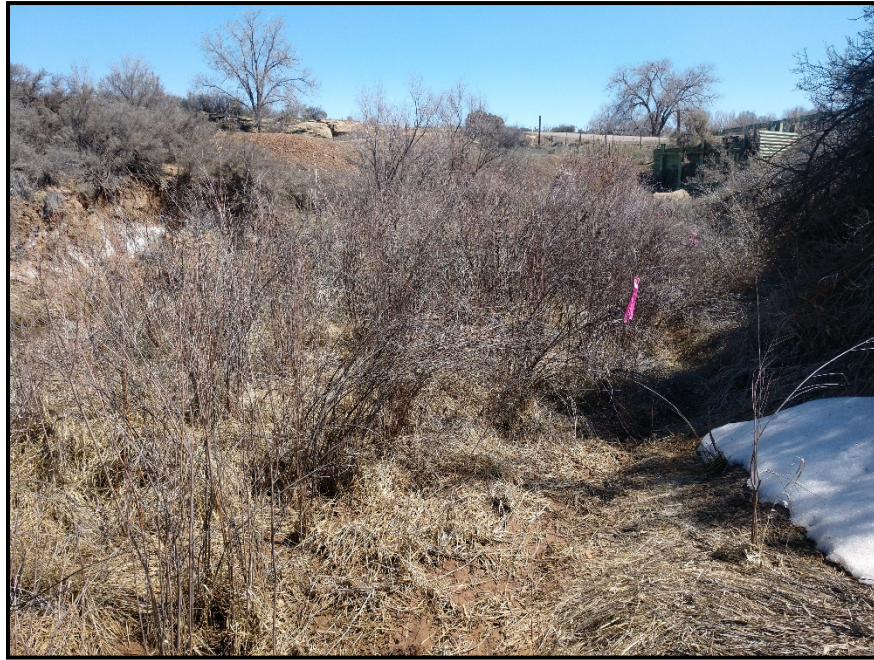
Photo Point 1 (PP1) is looking southeast at a palustrine scrub-shrub (PSS) wetland (Area A) that is a fringe wetland along Alkali Creek (photo left) in the northern portion of the survey area.

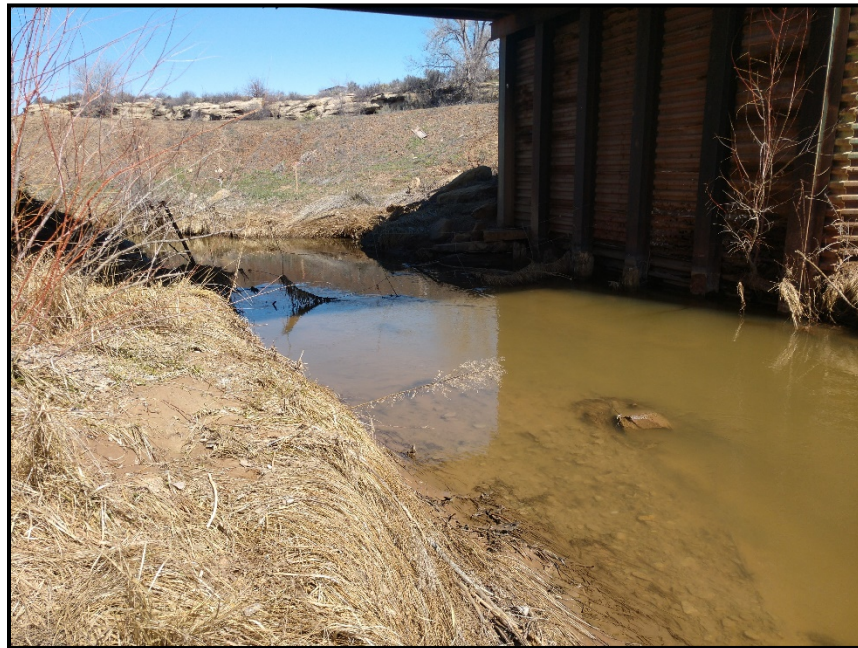
PP2 is looking northeast at Alkali Creek (Area C) under the current bridge along County Road N (CR N).

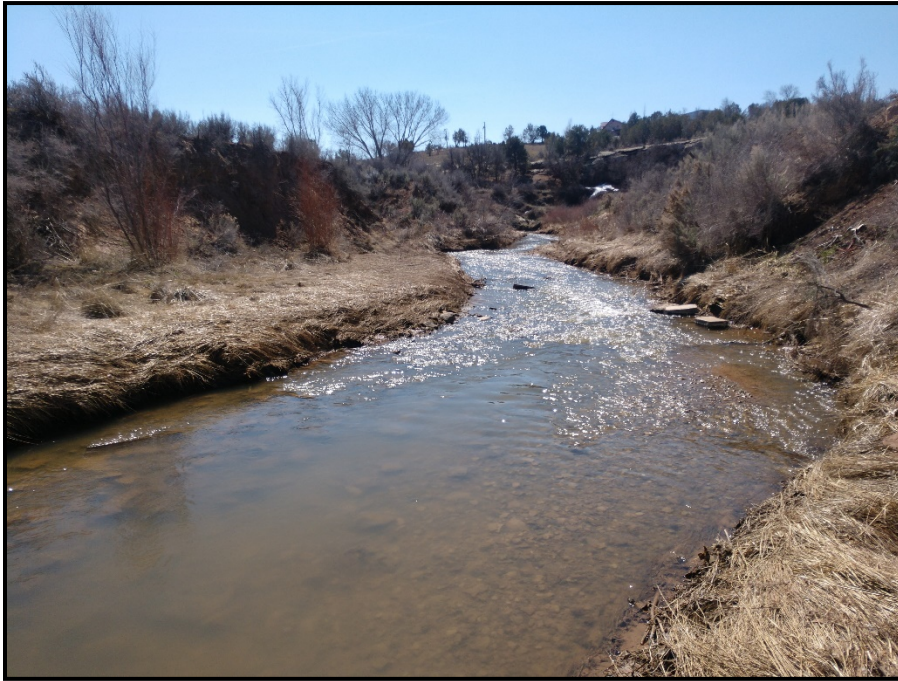
PP3 is looking south at the portion of Alkali Creek (Area C) south of CR N near the existing bridge. Fringe wetlands (Areas D and E) are located on both sides of Alkali Creek throughout this area, to the west and east, respectively. Datapoint 1 (DP 1) is located just behind (north) of this photo.

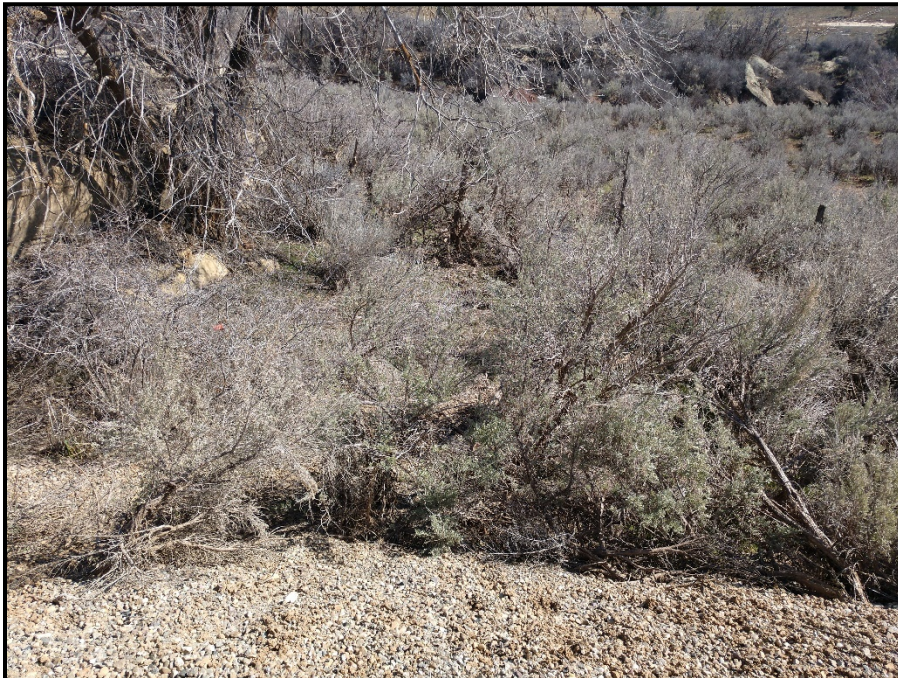
PP4 is looking west at an area that characterizes the uplands in the western portion of the survey area. This area is dominated by upland shrubs, including rubber rabbitbrush (*Ericameria nauseosa*) and big sagebrush (*Artemisia tridentata*).

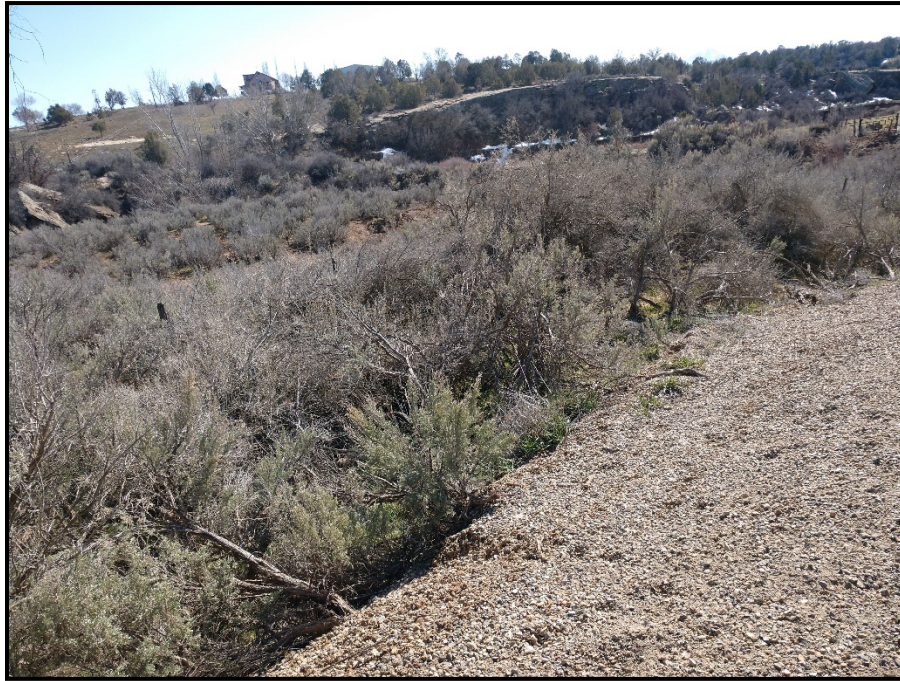
PP5 is looking southeast at an area that characterizes the uplands in the eastern portion of the survey area. This area is dominated by upland shrubs, including rubber rabbitbrush and big sagebrush.
